THAMES RIVER BASIN
MONTVILLE, CONNECTICUT

OXOBOXO LAKE DAM
CT 00238

PHASE 1 INSPECTION REPORT
NATIONAL DAM INSPECTION PROGRAM

DEPARTMENT OF THE ARMY
NEW ENGLAND DIVISION, CORPS OF ENGINEERS
WALTHAM, MASS.

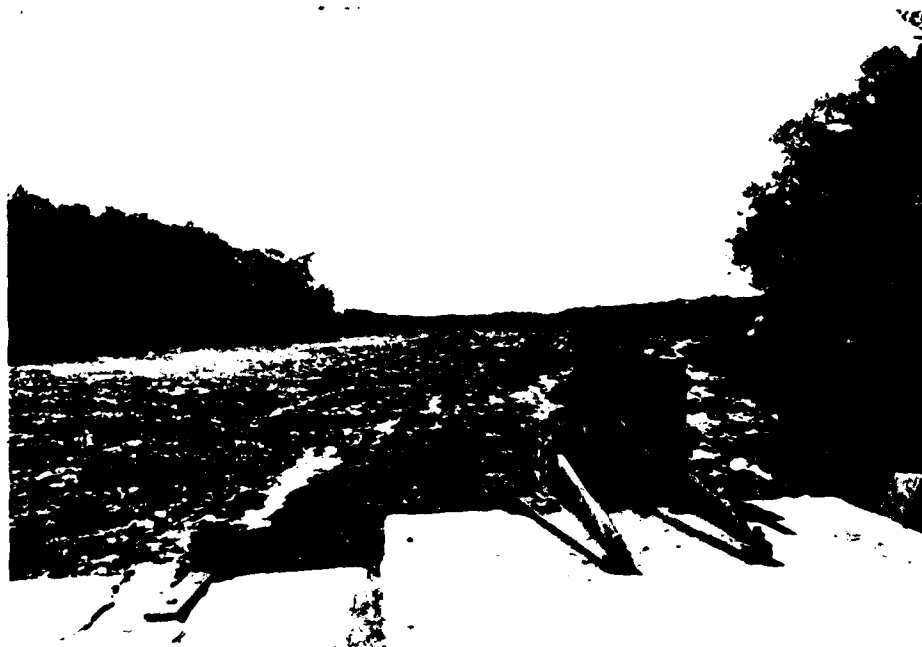
The gate mechanism for the outlet conduit is located on a pilaster on the upstream face at the approximate center of the dam. The mechanism is somewhat corroded and had been repaired by recent welding, but was operated during the inspection. Guides and trash racks for the gate were not observable; however, what appeared to be an upper support for the trash rack was broken and detached from the masonry.

C-6 OUTLET CONTROL MECHANISM

4. While the impoundment level is reduced, examine the outlet gate with particular attention to the trash rack and rehabilitate or replace it as necessary.

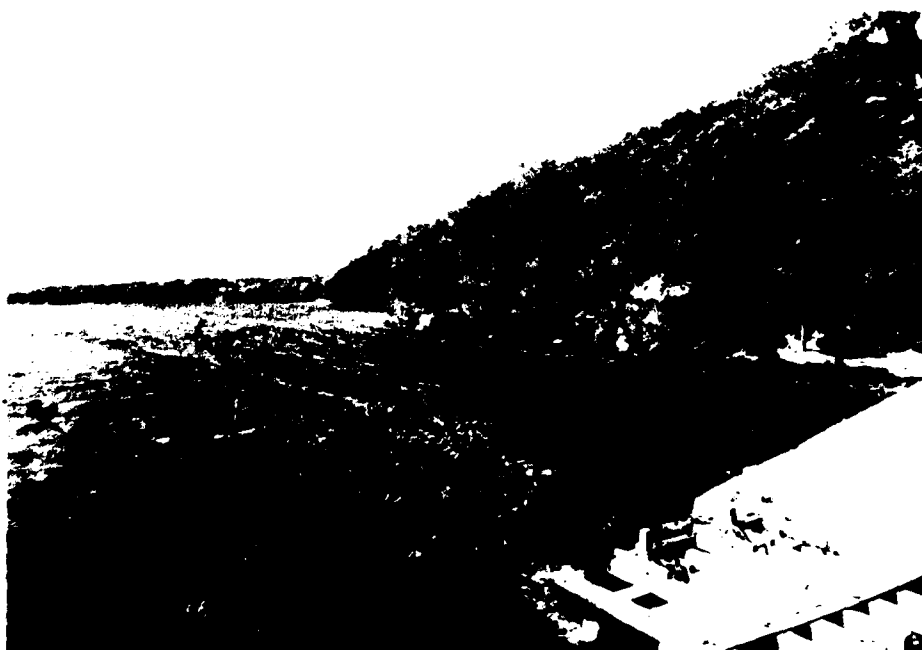
The overflow spillway was located on the right abutment of the dam and founded on the exposed bedrock in that location. Two low level gates of unknown size and invert were inoperable and in bad disrepair. The timber superstructure

supporting the gate control mechanism was completely deteriorated and near collapse. (See photo C-2, C-7). The condition of the screens, trash racks and gate guides for these low level outlets were below water and not observable.

C-7 SPILLWAY AND SPILLWAY GATE CONTROL STRUCTURE
(FOREGROUND)

5. During this same period of reduced water level, inspect and repair the low level spillway gates to increase the outlet capacity of the dam.
